100 Years of Experience in Ageing of Masonry Dams and life-time-based Rehabilitation

V. Bettzieche, R. Deutsch & C. Heitefuss

Ruhr-River-Association, Kronprinzenstr. 37, D-45128 Essen, Germany

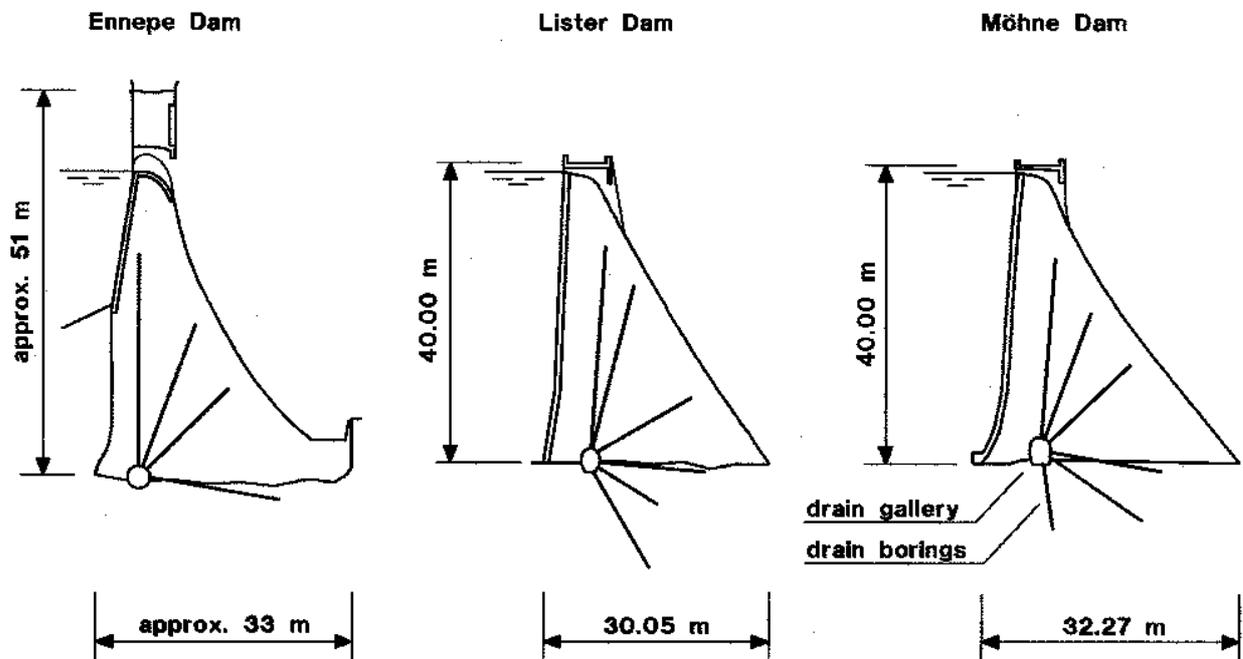
Figure 1. Masonry dams of the Ruhr-River-Association, rehabilitated with drain systems

Several circumstances caused the malfunction of these systems after more than 60 to 90 years in operation. The Moehne Dam (40 m high, build in 1913) was damaged in World War II and rapidly rebuild without the drainage system. The Lister Dam (42 m high, build in 1912) was reconstructed because it was included in the new Bigge Reservoir in 1965. The Ennepe Dam (50 m high, build in 1904) had to be rehabilitated because the drainage system was unintentionally filled by injections in the sixties (Fig. 1).

As this rehabilitation concept turned out to be rather cost-efficient the Ruhr-River-Association implemented drainage galleries and drain borings inside of these three masonry dams. These galleries serve as means for the inspection of the condition of the foundation surface, as well as drainage system for increased water pressures. Their special advantage is the fact, that they can be used later on for cost-efficient repair works of the dam and the bedrock.

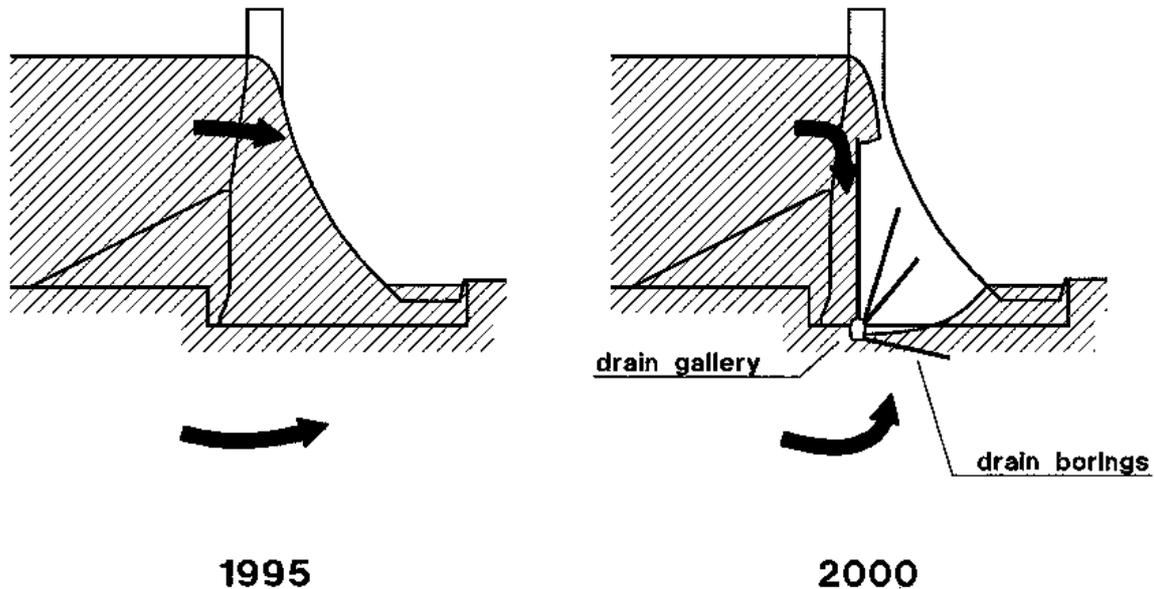
Figure 2. Realised concept of rehabilitation, using draining at the Ennepe Dam

In June 1997 the 93-year-old Ennepe Dam was taken over by the Ruhrverband. The Ennepe Dam had to be adapted to the established technical standards and safety regulations. The construction of a drainage- and inspection gallery (Fig. 2) with a Tunnel Boring Machine has been the most spectacular part of the rehabilitation work:

- the construction of a drainage gallery close to the upstream face at normal reservoir level and
- to drain masonry and bedrock with fans of drainage borings.

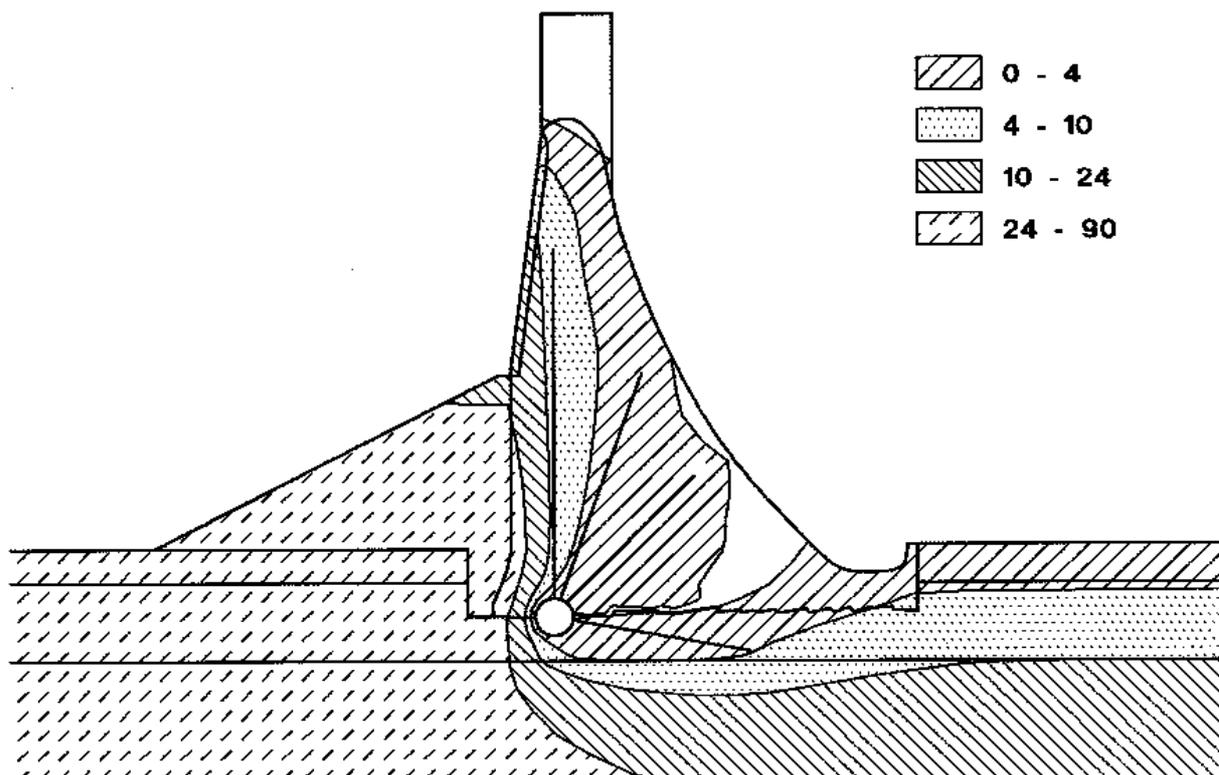
The drainage effect of this fan was examined with a lateral distance of 3 m and 4 m. The computed field of porepressure is shown in fig. 3. The seepage flow seeps from the upstream face of the dam to the drain gallery and borings. A small portions drips backward from the stilling basin into the masonry.

A free surface appears below the crest. Nevertheless the quantities of seepage through the masonry is very small, because of the small potential gradient.

A strong potential dismantling takes place between the upstream face and the first drainage. Because of the highly accepted permeability (to be on the safe side) of the intze wedge, the largest quantity of water seeps by this way and then through the upper rock layer to the drainages. Between the third drainage and the downstream face an insatiated zone develops. Due to the higher permeability of the upper rock layer, this insatiated zone reaches nearly to the inspection gallery.

Figure 3. Seepage in a cross section of the Ennepe Dam (water pressure in m)

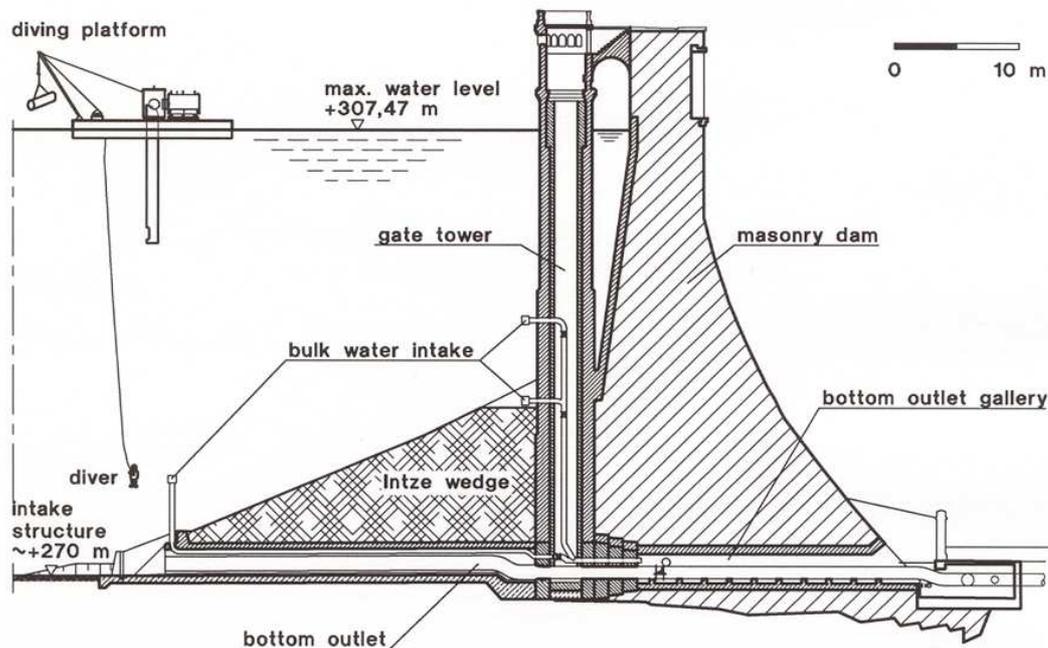
Figure 4. Cross section of Ennepe Dam after rehabilitation

Figure 4 shows a cross section of Ennepe Dam after rehabilitation with new pipework and a new guard valve inside the bottom outlet gallery. Inspection, maintenance or even replacement of this valve is now possible without restrictions anytime.

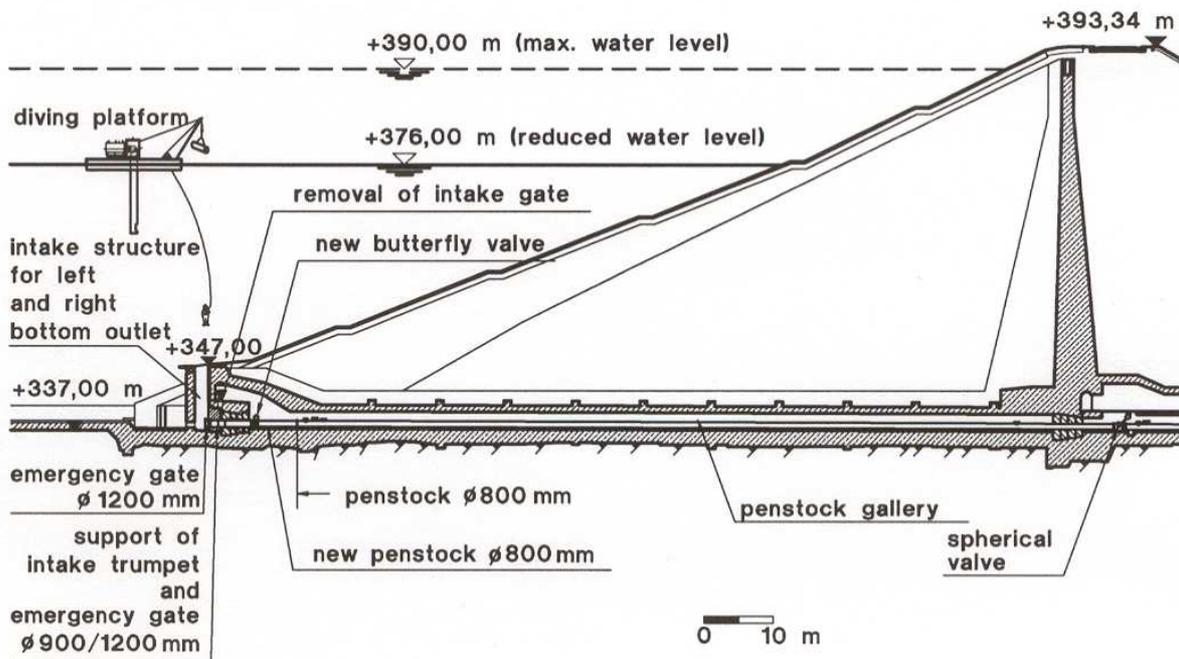
The valves at the bottom of the gate towers have been installed in the beginning of the 20th century and show strong symptoms of deterioration and signs of spongiosis after almost one century of operation. The gate towers itself usually prove to be in very bad condition as well. Due to leakages any inspection or maintenance work at the bottom of the towers is usually impossible.

Fig. 5: Cross section of Verse Dam during rehabilitation

The basic principle for the rehabilitation of the entire bottom outlet structures is based upon the following ideas and has been applied at the Verse Dam as shown in fig.5:

- to move the new intake trumpets to the upstream side outside the structure
- to use the new intake trumpets as support structures for emergency gates
- to replace the old intake gates and replace them by a new guard valve inside the penstock gallery
